Bomen Solar Farm

Responses to Independent Audit Recommendations

February 2020

Bomen Solar Farm - SSD 8835

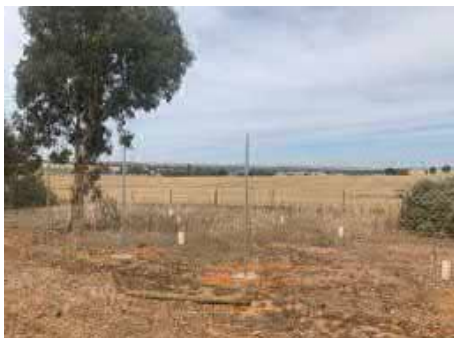
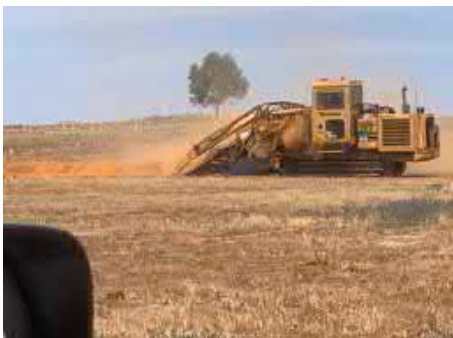
<p>Photo 21: Evidence of vegetation planting within southern solar farm development area.</p>	<p>Photo 22: Evidence of vegetation planting within southern solar farm development area.</p>

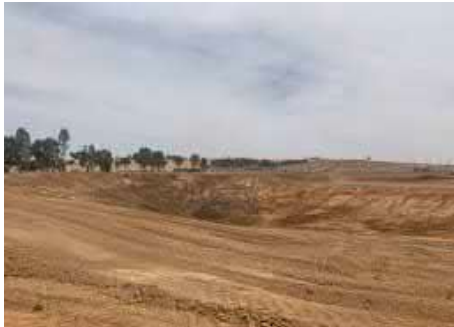
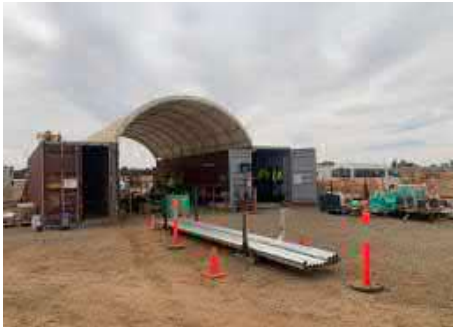
<p>Photo 23: Evidence of screening plantings within protected vegetation zones around site.</p>	<p>Photo 24: Trenching machinery on site, with localised dust.</p>
